S/Y \_\_\_\_\_

Valves and Thru Hulls

May 12, 2015

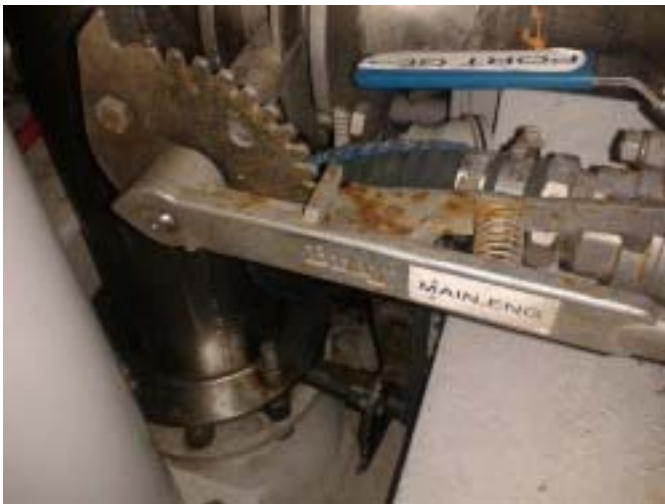
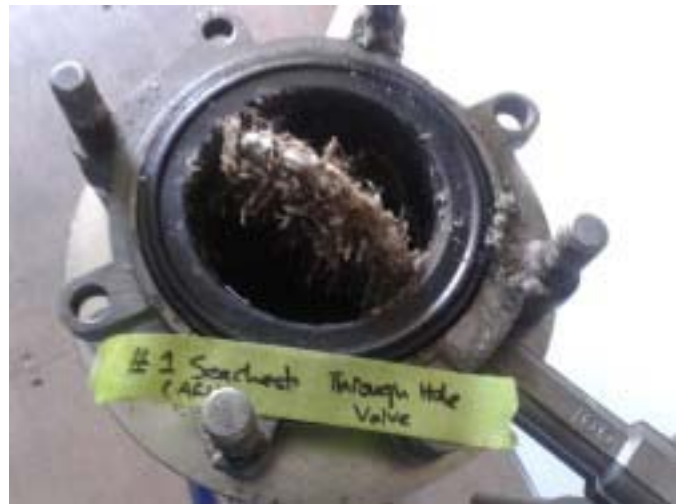
#9 Main Sea Chest 4"

| <b>Valve #</b> | <b>Valve Description</b> | <b>Service Performed</b> |
|---|---|--|
| 9 | 4" Main Sea-chest intake for Main Engine, Generators, Water Maker, A/C & Refrigeration (Below Water Line) | Valve PT at 110psi / <b>pass</b> , new liners, new ( <i>Butterfly disc and stem are SAF Duplex</i> ) |

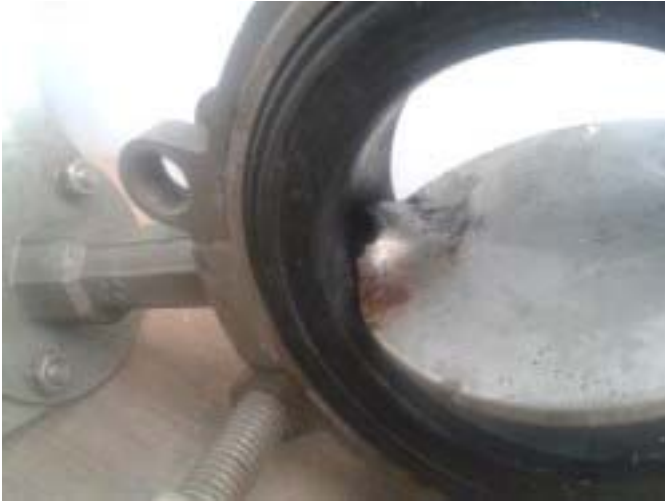
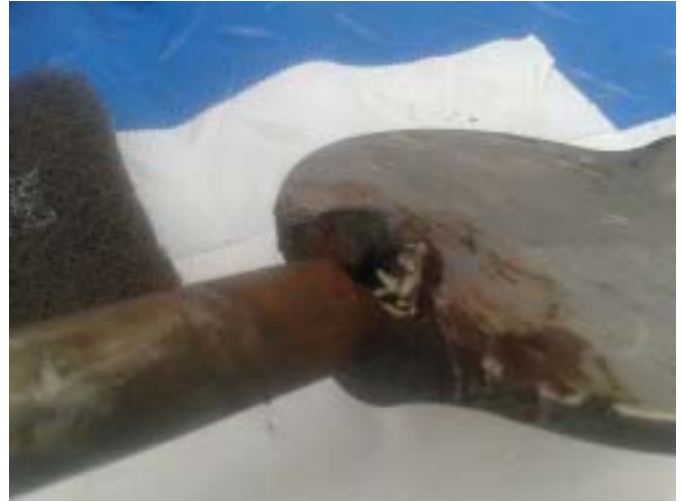
#11 Discharge

| <b>Valve #</b> | <b>Valve Description</b> | <b>Service Performed</b> |
|---|---|--|
| 11 | 4" Discharge for Water Maker, A/C & Refrigeration (Under Water) | Valve PT at 110psi / <b>pass</b> , new liners, new isolation disc, valve body machined to accept new disc and stem SAF Duplex SS |

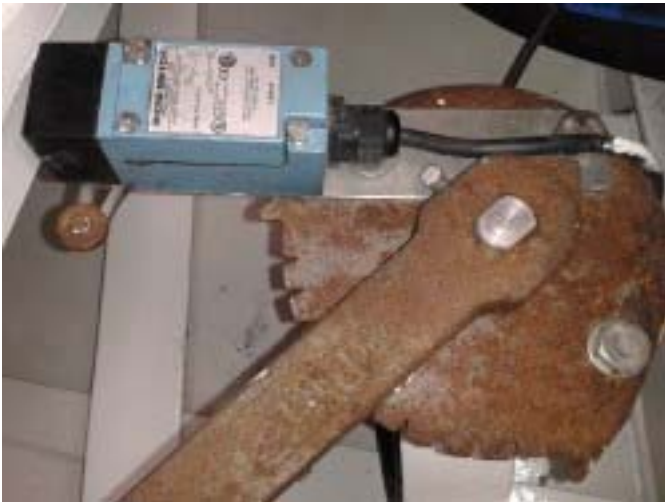
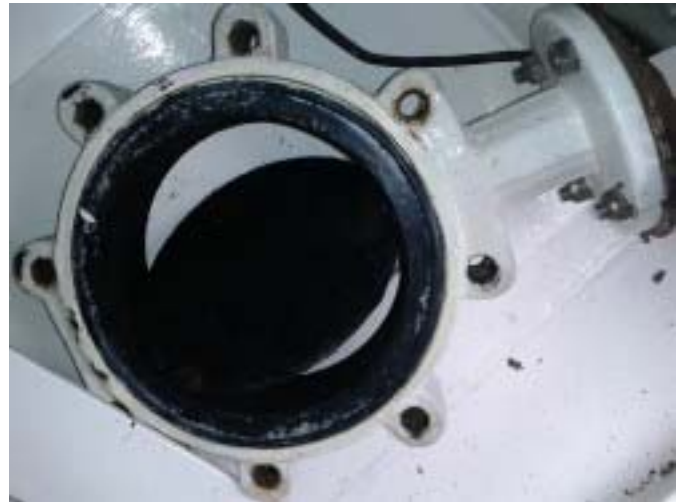
#5 Main Engine Exhaust

| <b>Valve #</b> | <b>Valve Description</b> | <b>Service Performed</b> |
|---|---|--|
| 5 | 8" Main Engine exhaust discharge (Above Water Line) | Valve PT at 110psi / <b>Fail</b> , Valve Replaced with Bray 8" series 21-0800-11010-1FABFV |

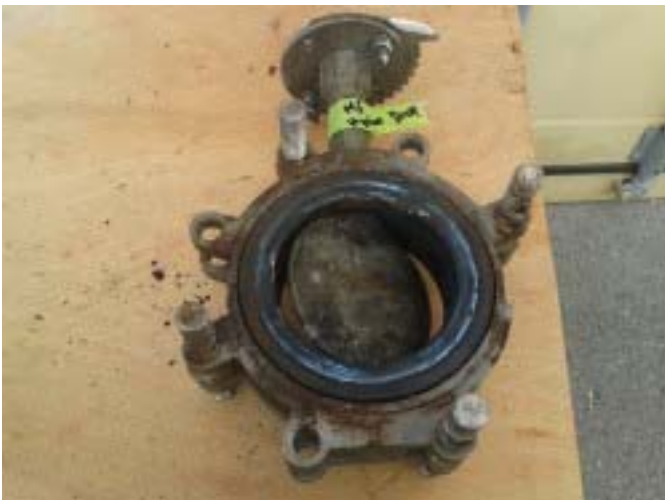
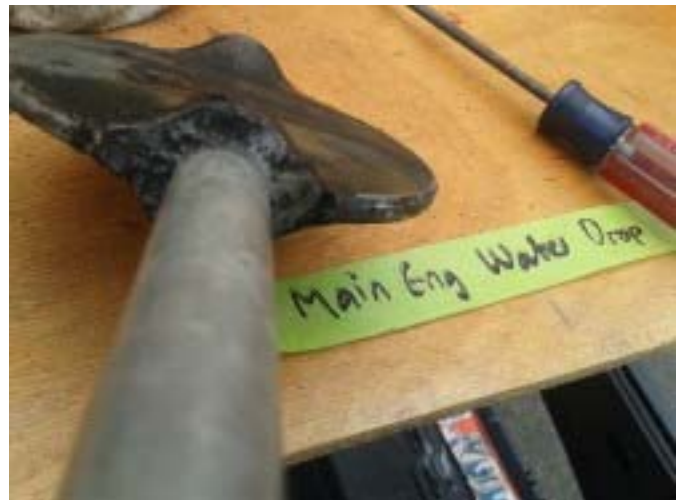
#7 Main Engine Water Discharge

| <b>Valve #</b> | <b>Valve Description</b> | <b>Service Performed</b> |
|---|---|--|
| 7 | 3" Main Engine exhaust water discharge (Below Water Line) | Valve PT at 110psi / <b>pass</b> , new liners, new isolation disc, valve body machined to accept new disc and stem SAF Duplex SS |

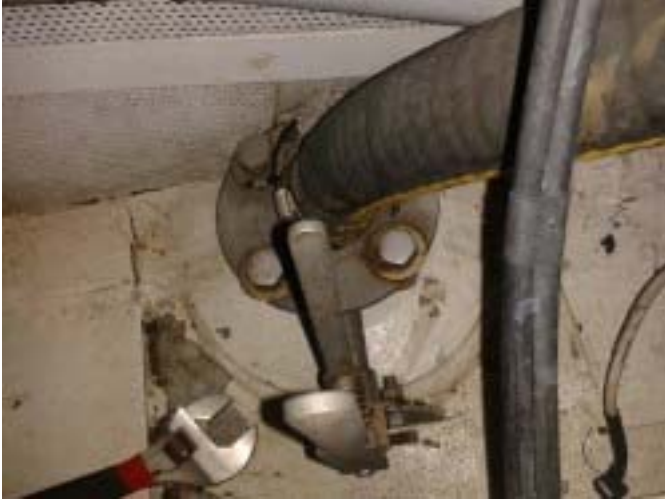
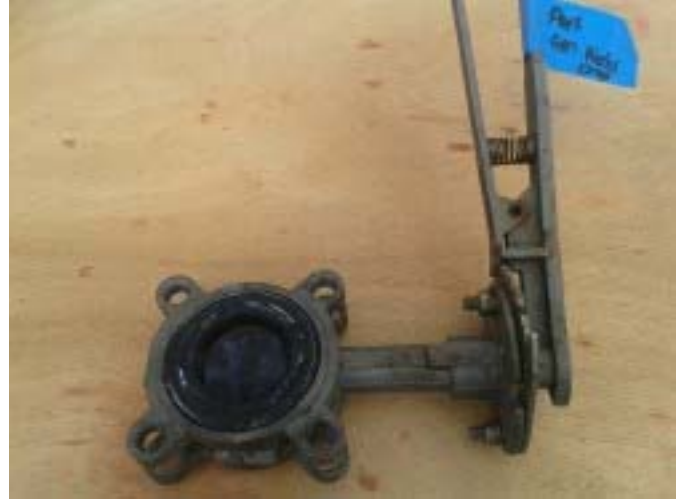
#2 Port Generator Water Discharge

| Valve # | Valve Description | Service Performed |
|---|--|--|
| 2 | 2" Port Generator exhaust water discharge (Below Water Line) | Valve PT at 110psi / <b>pass</b> , new liners, new isolation disc, new butterfly disc and stem 316L SS |

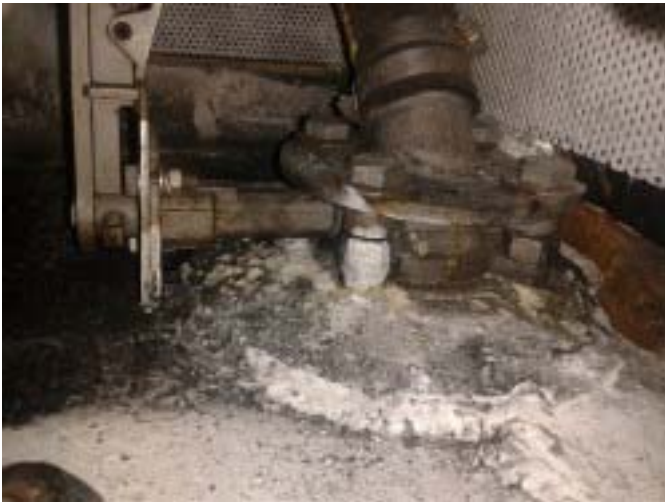
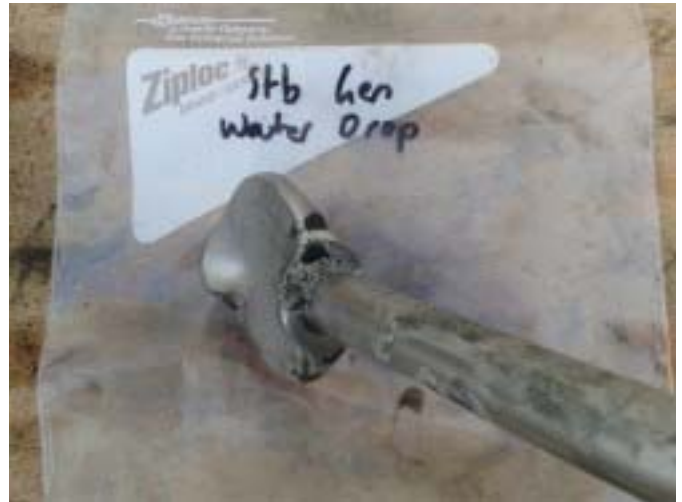
#6 Stbd. Generator Water Discharge

| <b>Valve #</b> | <b>Valve Description</b> | <b>Service Performed</b> |
|---|---|--|
| 6 | 2" Stbd Generator exhaust water discharge (Below Water Line) | Valve PT at 110psi / <b>pass</b> , new liners, new isolation disc, new butterfly disc and stem 316L SS |

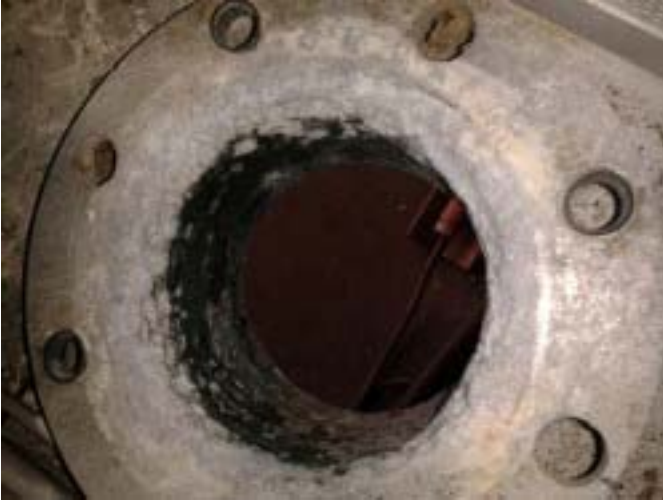
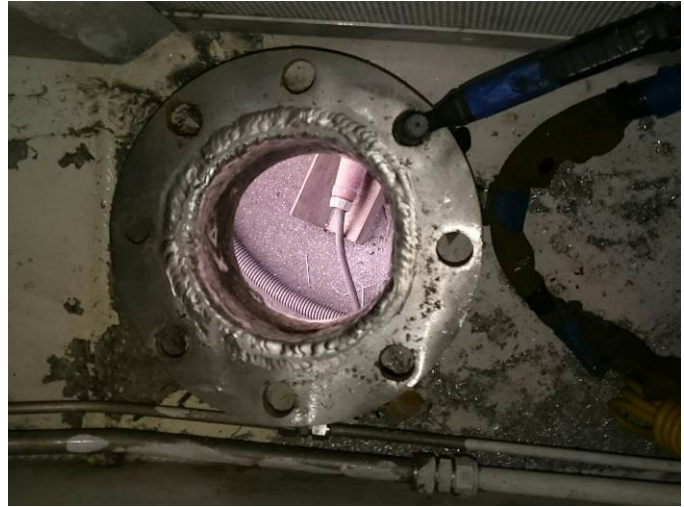
During the removal of the valves, two of the thru hulls were found to have pitting and corrosion. These areas have been clad welded and new coatings applied as required.

The thru hulls repaired are relative to the valves #3 below the water line, and #1 above the water line.

# 3 Before / After but Before Welds Have Been Ground Back

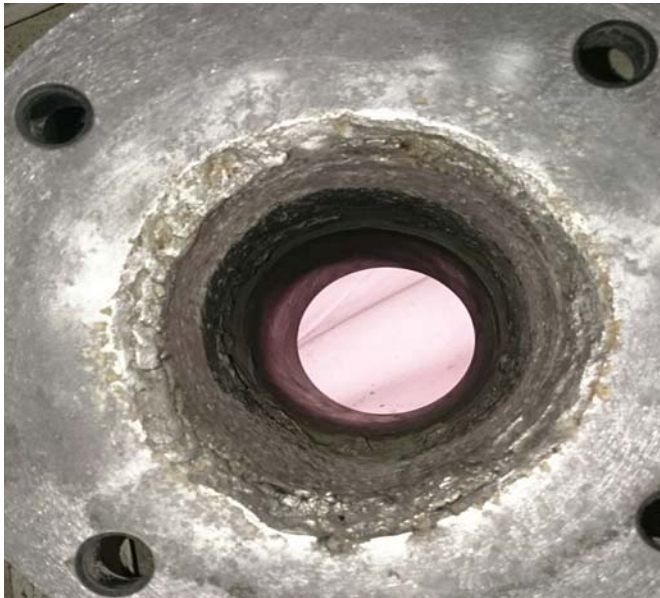
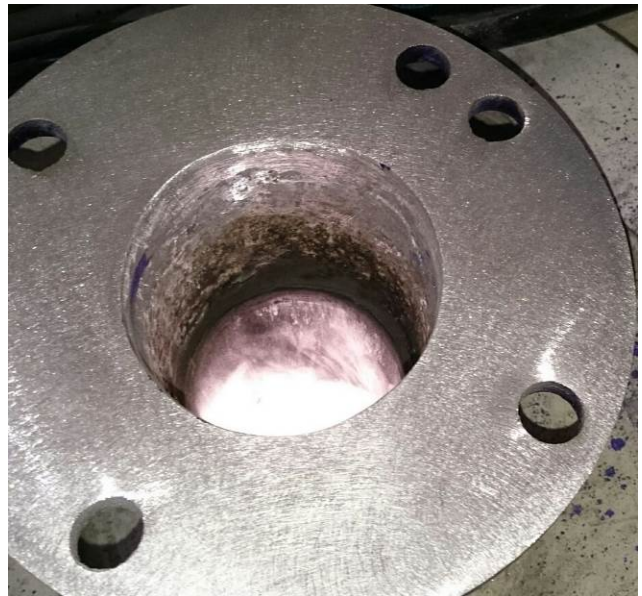
#1 Before / After Welding and Grinding
